DEPARTMENT OF TRANSPORTATION

Contract #: 04-0120F4Cty: SF/ALA Rte: 80 PM: 13.2/13.9File #: 69.28**WELDING INSPECTION REPORT****Resident Engineer:**Pursell, Gary**Address:** 333 Burma Road**City:** Oakland, CA 94607**Report No:** WIR-002539**Date Inspected:** 21-May-2008**Project Name:** SAS Superstructure**OSM Arrival Time:** 1400**Prime Contractor:** American Bridge/Fluor Enterprises, a JV**OSM Departure Time:** 2300**Contractor:** Zhenhua Port Machinery Company, Ltd (ZPMC), Changxing Island **Location:** Shanghai, China

Bridge No: 34-0006**Component:** OBG side and bottom panels and tower skin p**Summary of Items Observed:**

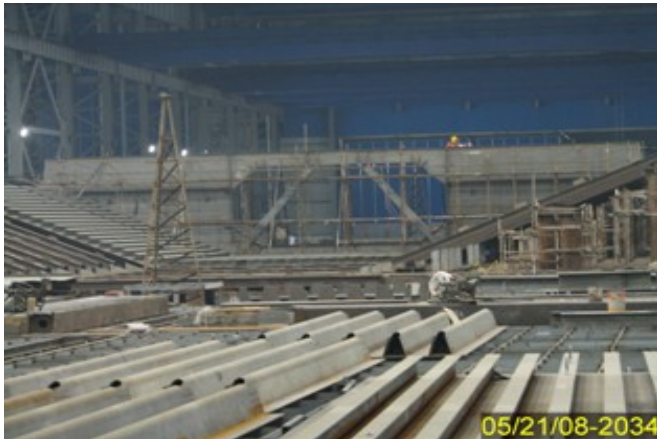
Other general observations in the New Tower bays include ZPMC tack welding tower skin plates, weld bevel preparation, flame straightening, CNC parts cutting and grinding.
